CF6 JET ENGINE DIAGNOSTICS PROGRAM

LONG-TERM CF6-6D LOW-PRESSURE TURBINE DETERIORATION

AUGUST 1979

GENERAL ELECTRIC COMPANY

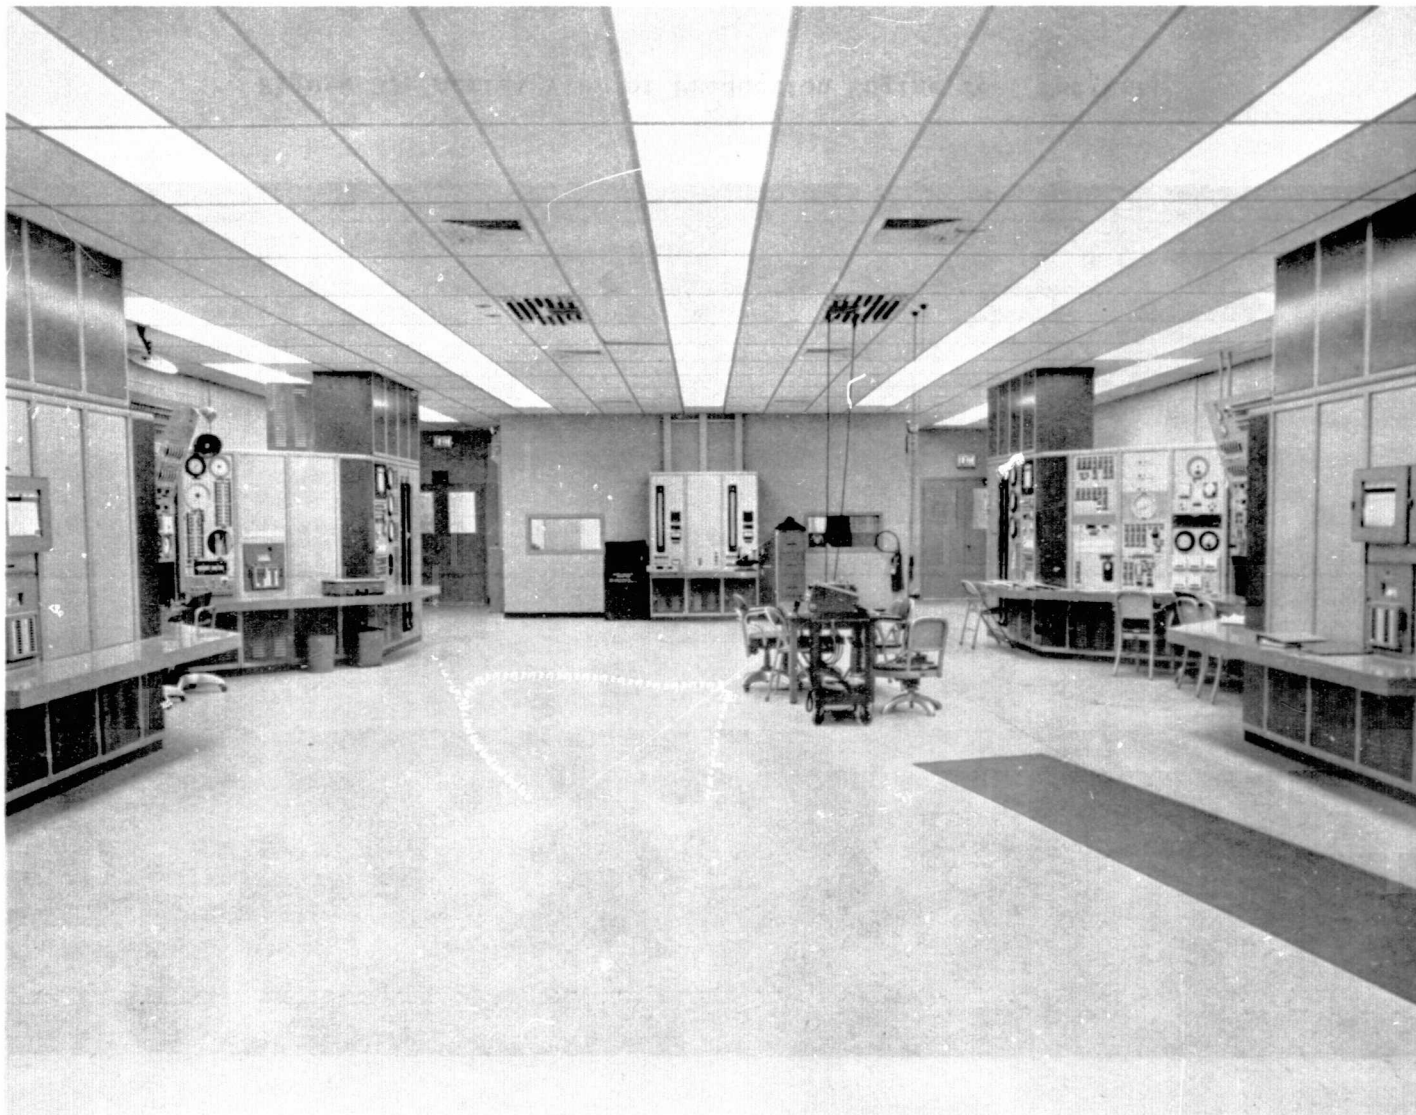
Figure 6. Production Engine Test Facility Control Room.

The General Electric High-Bypass Fan Production Engine Test Facility, shown in Figure 5, is located in Evendale, Ohio. It consists of two cells, M34 and M35, separated by a common access aisle on the lower level and by a control room (Figure 6) on the second level. Figure 7 shows the engine "prep" area located between the two cells. Auxiliary equipment rooms are
